MOUNT HOOD COMMUNITY COLLEGE HPE BUILDING

SEISMIC EVALUATION AND CONCEPTUAL SEISMIC STRENGTHENING DESIGN

DECEMBER 21, 2015

KPFF PROJECT NO. 213276.40

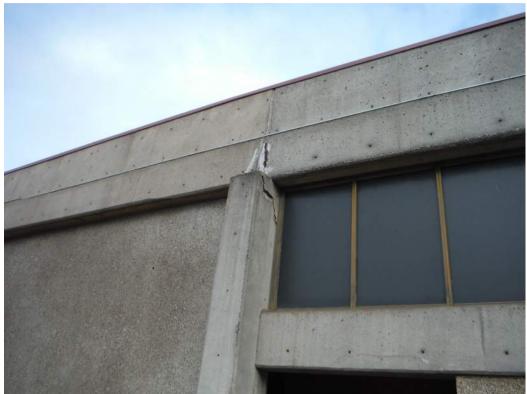
Spalling of concrete due to rebar corrosion was also observed above the entrance on the north side of the building (Photo 1). This is not expected to directly affect the seismic force resisting system, but could be exacerbated during a seismic event creating a falling hazard. The strengthening scheme includes repairs for this areas. The seismic force resisting system did not appear to have any visible damage.

Photo 1 - Spalling of Concrete at North Entrance

REPAIR SPALLING AT LOCATION ABOVE DOOR ON NORTH SIDE OF BUILDING.——

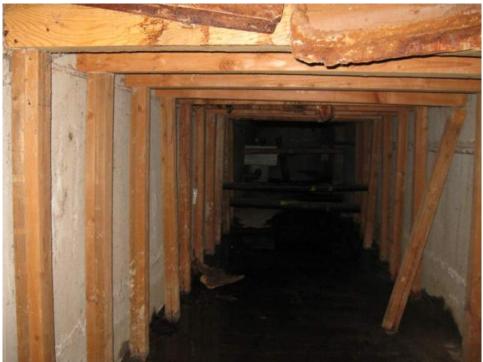
We also observed a structural deficiency in a subgrade utility tunnel that begins at the southeast corner of the HPE building and runs between the HPE building and gym. A section of the tunnel roof slab at the entrance between the gym and HPE building was damaged during electrical work. The roof slab was replaced along the damaged length with what appears to be a new reinforced concrete slab. Wood formwork and particle board remain in place (Photo 2). Ground penetrating radar (GPR) was used to determine the slab reinforcement. We found that the transverse reinforcement in the slab is insufficient and recommend that the slab is strengthened in this location. The strengthening scheme includes repairs for this area.

Photo 2 - Section of Tunnel Where Slab has been Repaired

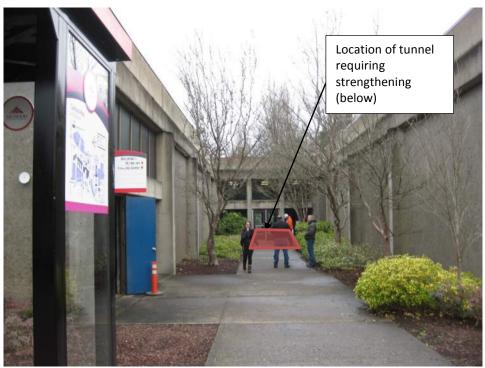
While the tunnel does not directly affect the seismic force resisting system, the deficient area is at a main building egress (Photo 3) and damage or failure of the slab could impede evacuation from the HPE building (and adjacent gym structure).

Photo 3 - Location of Tunnel Slab Requiring Strengthening

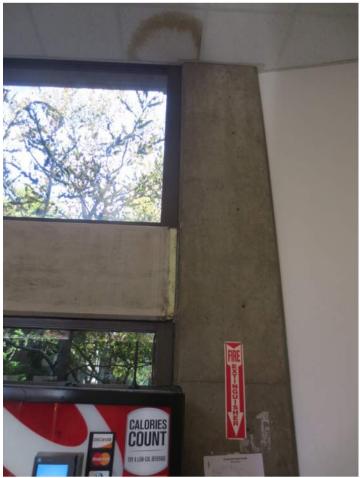
- The ceiling system is continuous across the seismic joint and is attached to two independent structures. This continuity will not account for any relative movement between the two structures (see Photo 4).

Photo 4 - Suspended Ceiling Continuous Across the Seismic Joint

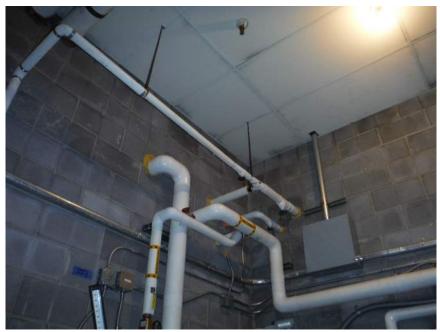
- Fire Suppression Piping should be braced and contain flexible couplings, current condition is unknown.
- Sprinklers that penetrate drop down ceilings do not contain adequate clearances (Photo 5).

Photo 5 - Sprinkler Head Clearance & Suspended Ceiling Tight to Adjacent Wall

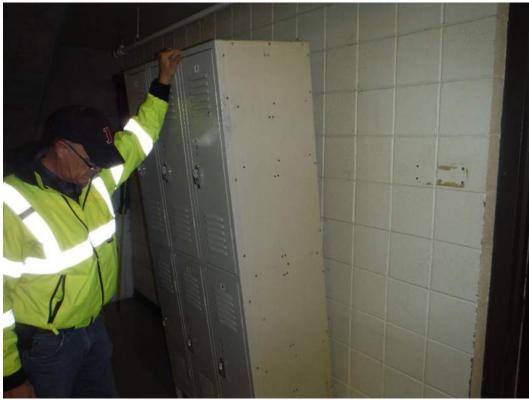
- The light fixtures within the suspended ceiling are not appropriately braced.
- There are a number of contents and furnishings that are not braced (Photo 6). These include:

Photo 6 - Example of Unbraced Furnishings

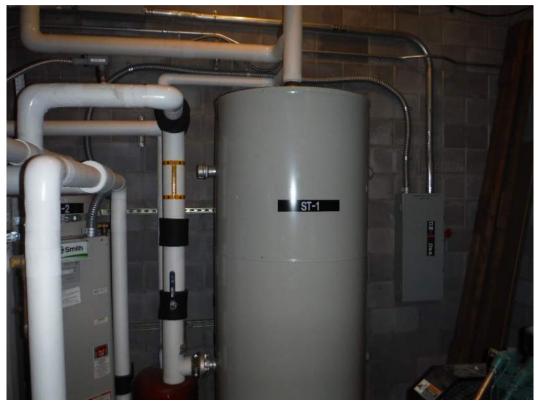
- Storage racks
 - Tall narrow contents
- Mechanical equipment was mostly secured except for a large hot-water heater (Photo 7).
- Electrical equipment weighing more than 20 pounds whose center of mass is more than 4 feet above the floor level and tall narrow electrical equipment should be braced and/or anchored.

Photo 7 - Unbraced Hot Water Heater

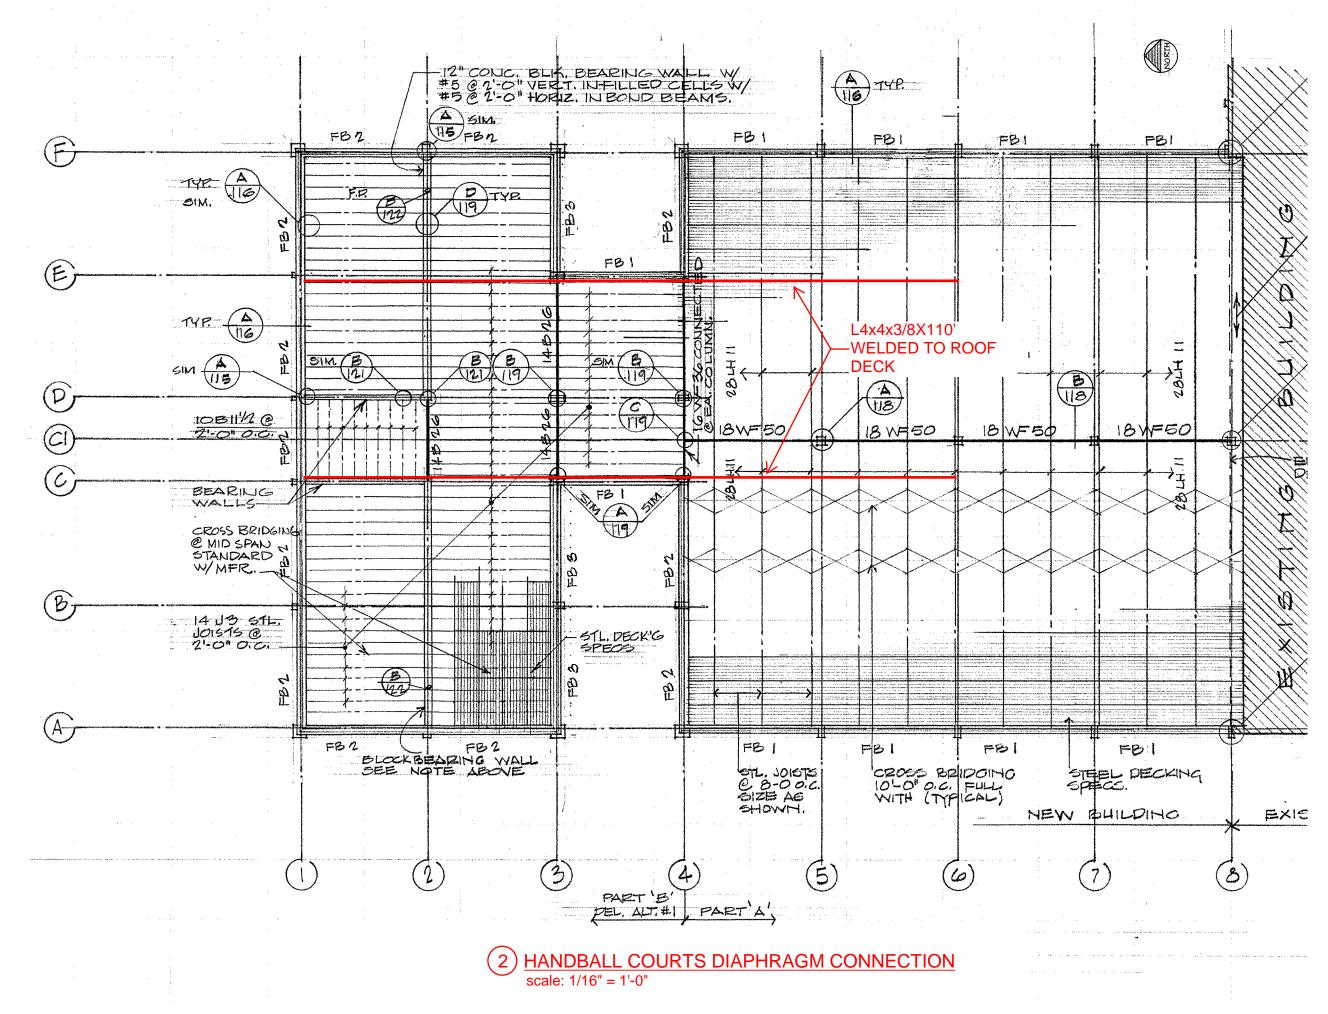
- Reentrant Corners/Diaphragm Transfer
 - The building narrows between the handball courts and main gym and at the foyer to the domed gymnasium. Strengthening elements should be added at these locations in order to ensure an adequate path for the transfer of forces between the diaphragm elements.

ADD CONTINUOUS L4x4x3/8 FOR TRANSFER DIAPHRAGM FORCES BETWEEN HANDBALL COURTS AND MAIN GYM.

WELD TO METAL ROOF DECK AT FLUTES (HAND BALL COURTS) AND AT SIMILAR SPACING ABOVE MAIN BUILDING.

AT PERPENDICULAR BEAMS AND WALLS, ANGLE SHOULD BE CUT AND WELDED, AS NECESSARY.
