MOUNT HOOD COMMUNITY COLLEGE HPE BUILDING

SEISMIC EVALUATION AND CONCEPTUAL SEISMIC STRENGTHENING DESIGN

DECEMBER 21, 2015

KPFF PROJECT NO. 213276.40

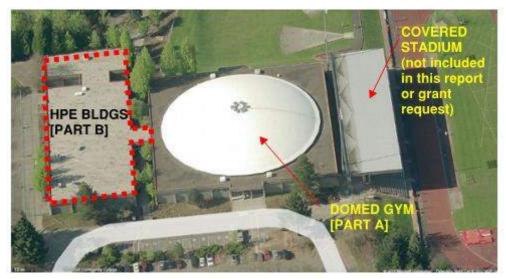
Figure 1 - MHCC Health and Physical Education Buildings

A 2" seismic joint between the ancillary building and the domed gymnasium qualifies them to be considered as two separate structures in the SRGP application (see Figure 1). The application does not include the covered stadium structure. In the SRGP application, the structures are identified as:
